UNDERWATER BRIDGE INSPECTION REPORT

STRUCTURE NO. 52504
CSAH NO. 24
OVER THE
MINNESOTA RIVER
DISTRICT 7 - NICOLLET COUNTY

PREPARED FOR THE
MINNESOTA DEPARTMENT OF TRANSPORTATION
BY
COLLINS ENGINEERS, INC.
JOB NO. 3512

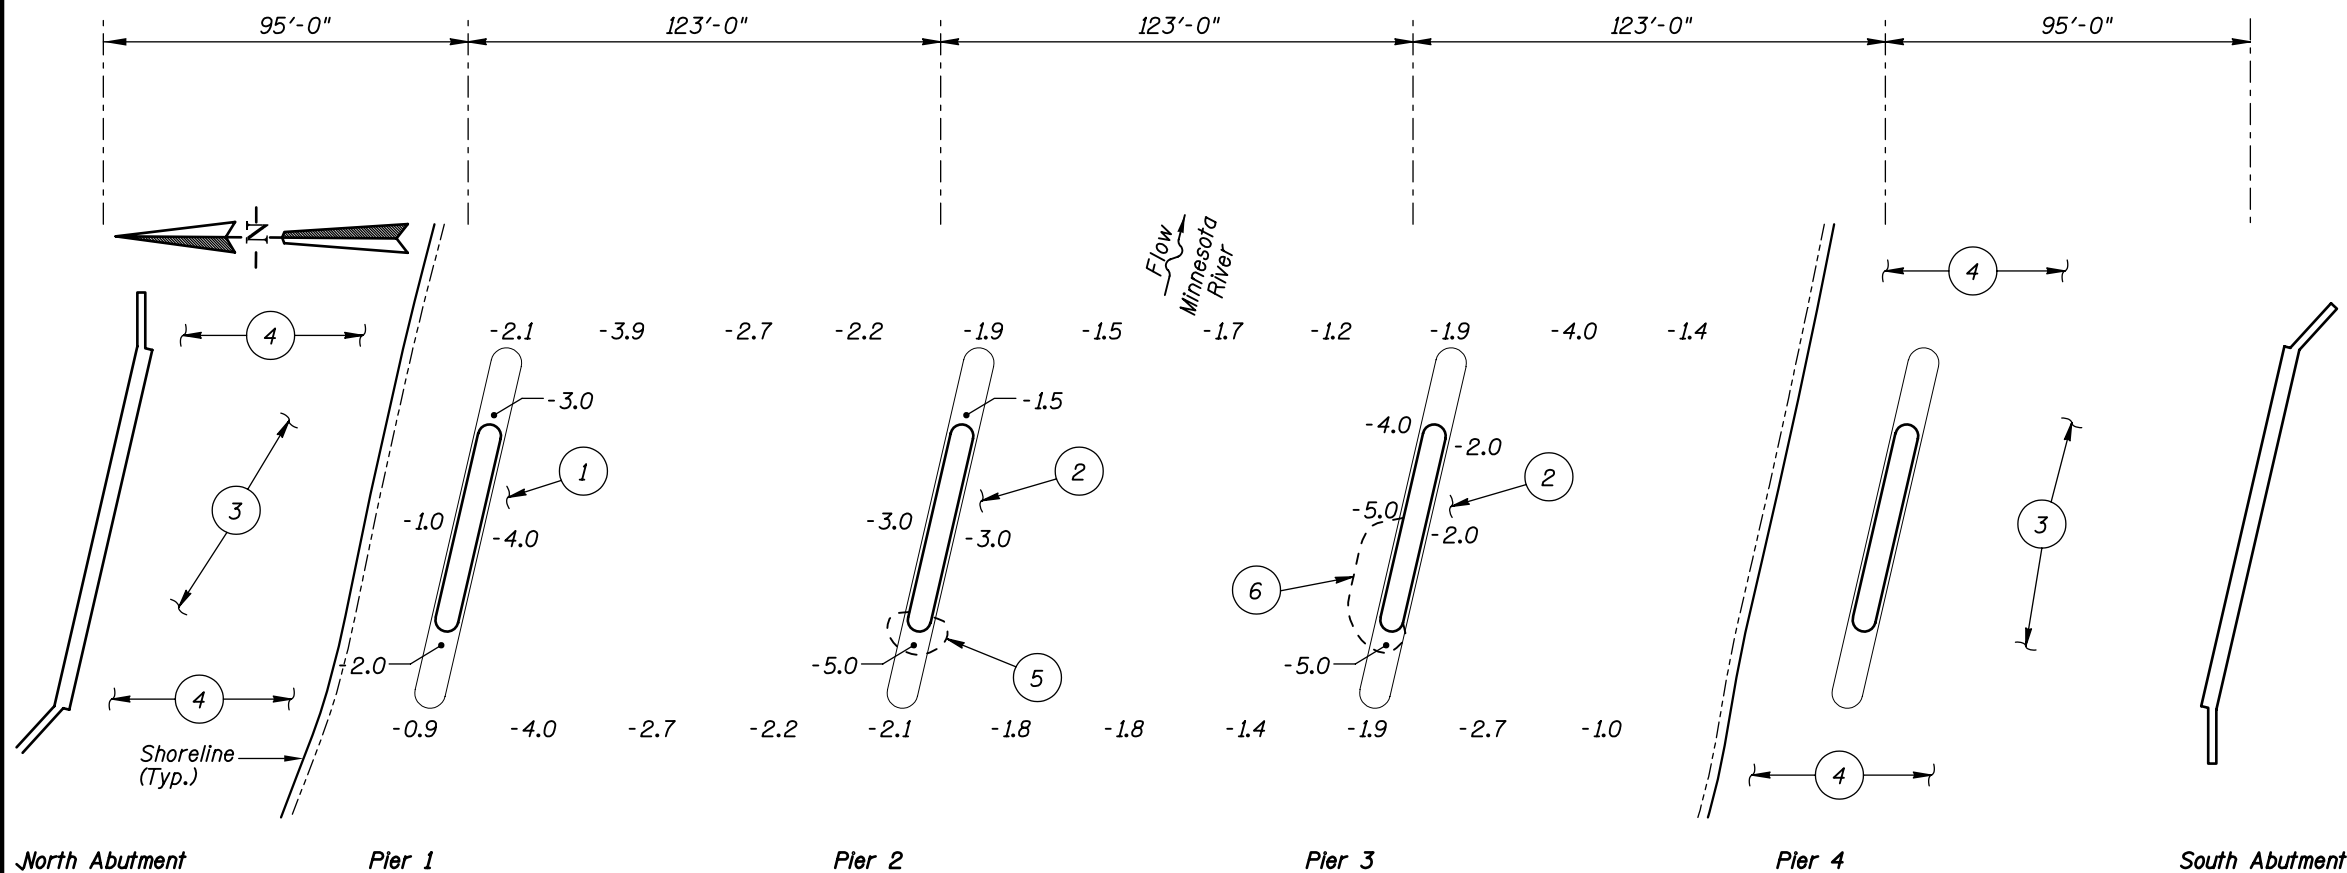
INSPECTION AND SOUNDING PLAN

- 1 The channel bottom material around the pier consisted of silty sand with up to 2 feet of probe rod penetration.
- 2 The channel bottom material around the pier consisted of sand with up to 1 foot of probe rod penetration.
- 3 The riverbanks beneath the bridge consisted of silty sand along the shoreline with riprap extending from the shoreline back to the abutment walls.
- 4 The upstream and downstream banks of the bridge exhibited steep vertical erosion of the banks.
- 5 A scour depression was observed around the upstream nose of the pier and measured up to 3 feet deep by approximately 4 feet in radius.
- 6 A scour depression was observed around the upstream nose of the pier and measured up to 3 feet deep and approximately 4 feet in radius, and extended approximately halfway along the north face of the pier.

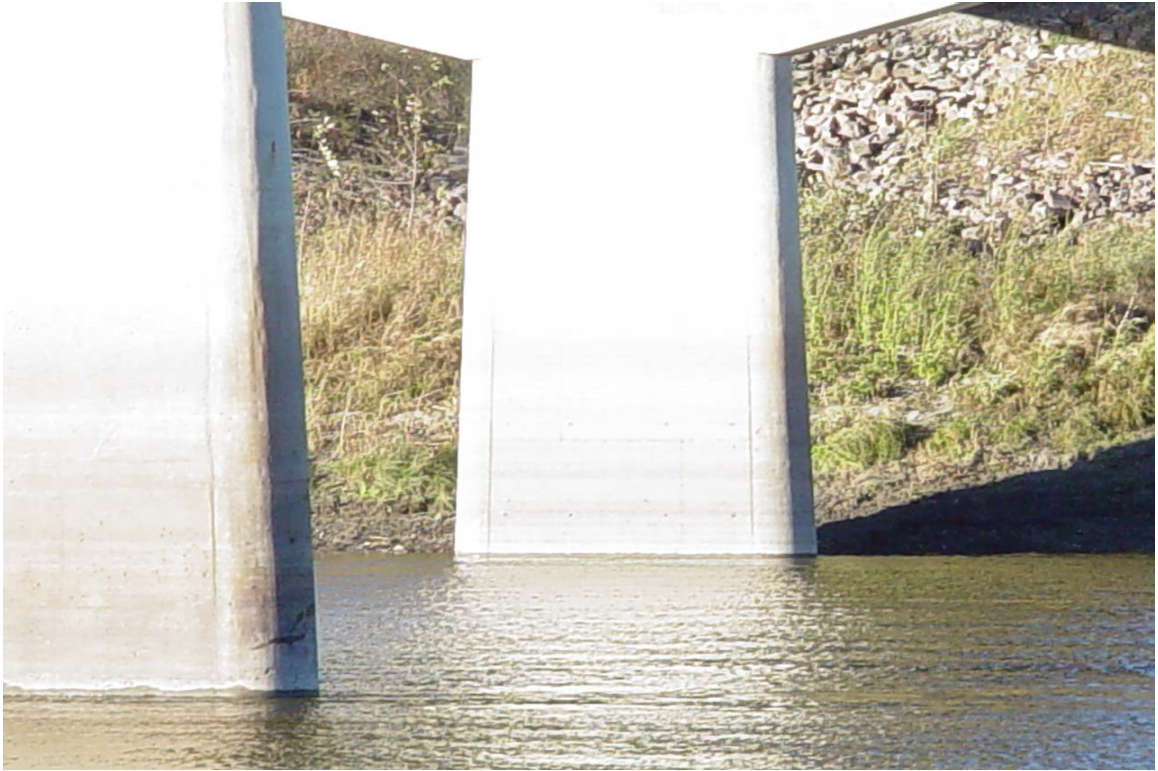
Photograph 3. View of Pier 1, Looking Northwest.

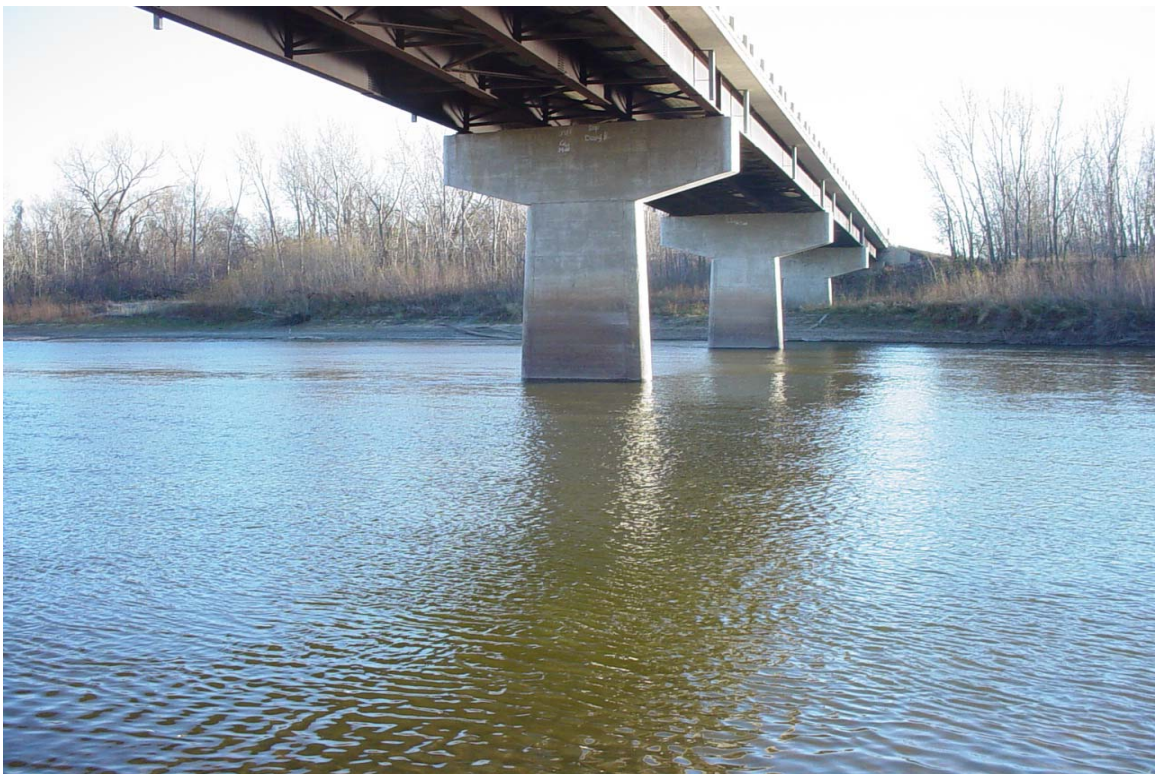
- (A) Overall, the concrete below water was in good condition with no structurally significant defects observed.
- (B) A scour depression was observed around the upstream nose of Pier 2 and measured up to 3 feet in depth by approximately 4 feet in radius.
- (C) A scour depression was observed around the upstream nose of Pier 3 and measured up to 3 feet in depth and approximately 4 feet in radius. The depression extended approximately halfway along the north face of the pier as well.

Photograph 4. View of Pier 2, Looking Southeast.

- (A) Reinspect the submerged substructure units at the normal maximum recommended (NBIS) interval of five (5) years.

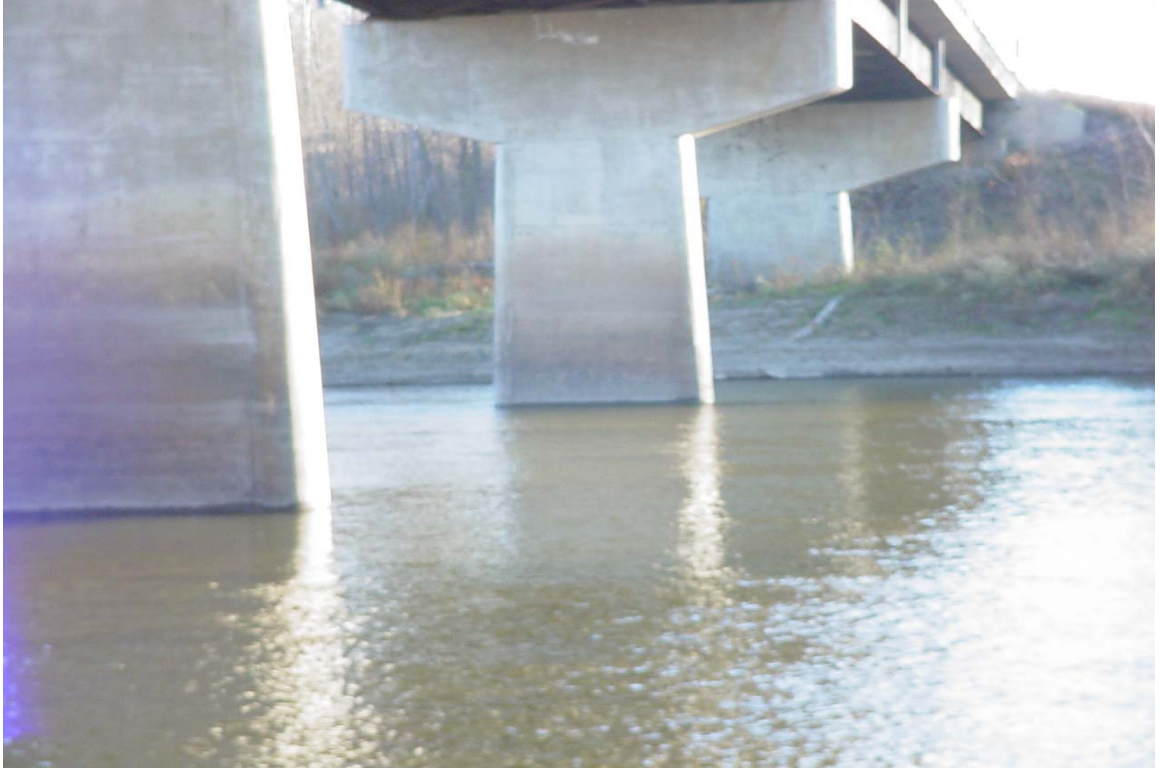
Photograph 5. View of Pier 3, Looking Southeast.
